NASA CONTRACTOR REPORT 166341

Testing of the Kuiper Airborne Observatory
91-CM Telescope

Robert E. Parks
Optical Sciences Center

CONTRACT NAS2-10085
July 1979

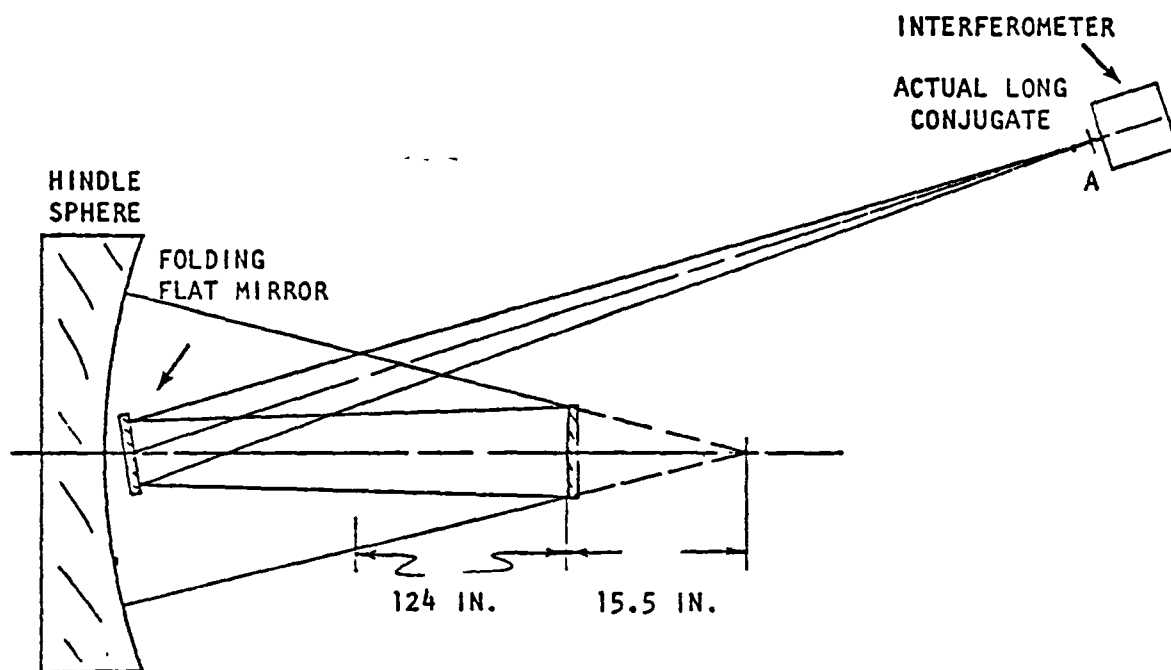
Fig. 5. Hindle Test for Hyperbolic Secondary Mirror.
A is the focal plane or long conjugate.

Because of some worry about the quality of the Cervit secondary supplied with the system, it seemed logical to test this component first. The classical test for both the manufacture and verification of quality of hyperbolic secondary mirrors is the Hindle test shown in Fig. 5. The secondary mirror is supported by its center mounting hole with its optical axis horizontal. An interferometer is placed at the long focus or conjugate of the secondary mirror at the same distance from the secondary as is the focal plane in the actual telescope. A Hindle sphere is placed with its center of curvature at the short focus or conjugate of the secondary mirror. This conjugate is at the same position relative to the secondary mirror as the focus of the

primary mirror is in the telescope. (The short conjugate is at the Newtonian focus of the primary mirror). In this configuration, light from the interferometer diverges up to the secondary. It causes a further divergence, making the light appear as though it were coming from the short conjugate or the secondary. This light diverges from the secondary in a spherical wavefront and is directed toward the Hindle sphere at normal incidence. The light then reverses direction at the Hindle sphere and returns to the interferometer. The data gathered by the interferometer show twice the wavefront error that the secondary would produce if it were in the actual telescope. Thus all the data obtained from our interferometric measurements were divided by two to account for the double sensitivity of the test of the secondary mirror.

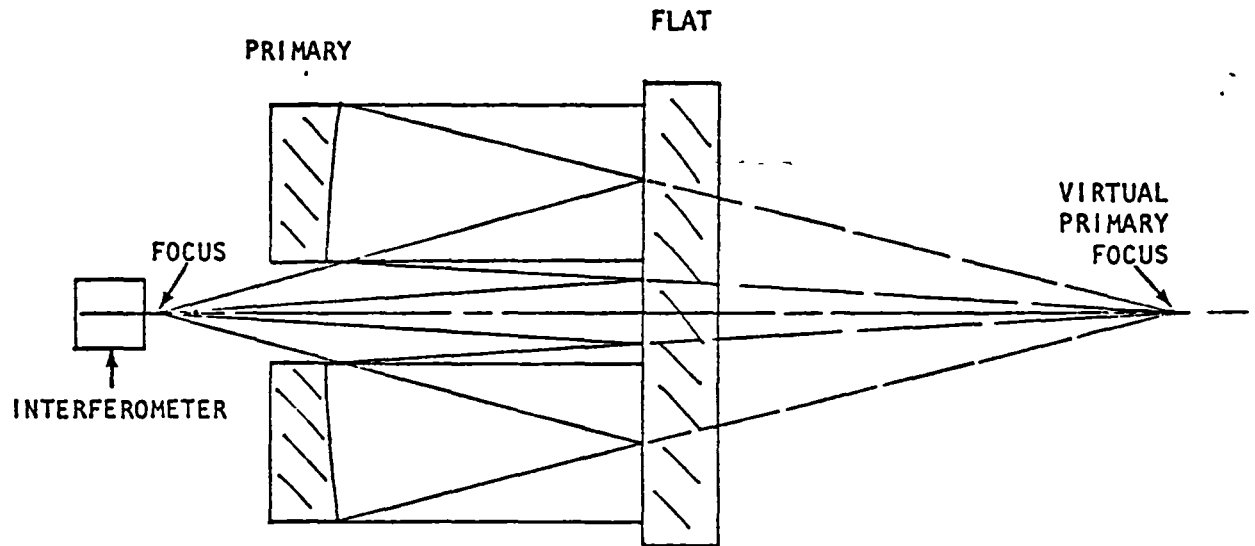
Fig. 11. Primary Mirror Test Against a Flat Mirror.

The next component to be tested was the primary mirror. The mirror was taken out of the cell and slung in a specially designed sling mount so that its axis would be horizontal. The sling mount did not interfere with the mounting pads on the edge of the primary mirror. The schematic of the primary mirror test is shown in Fig. 11. A flat mirror was

positioned at a little less than half the focal length from the primary so that there was easy access to the focus of the primary. The interferometer was placed at the focus of the primary as reflected in the plane mirror. Light from the interferometer diverged up to the flat and continued to diverge into the primary mirror. The primary mirror collimated the light and directed it toward the flat where it struck at normal incidence. The light then retraced its path back from the flat to the parabola and finally to the interferometer. This test was compact and allowed us to test the primary mirror with no larger obscuration than that due to the hole in the primary itself.

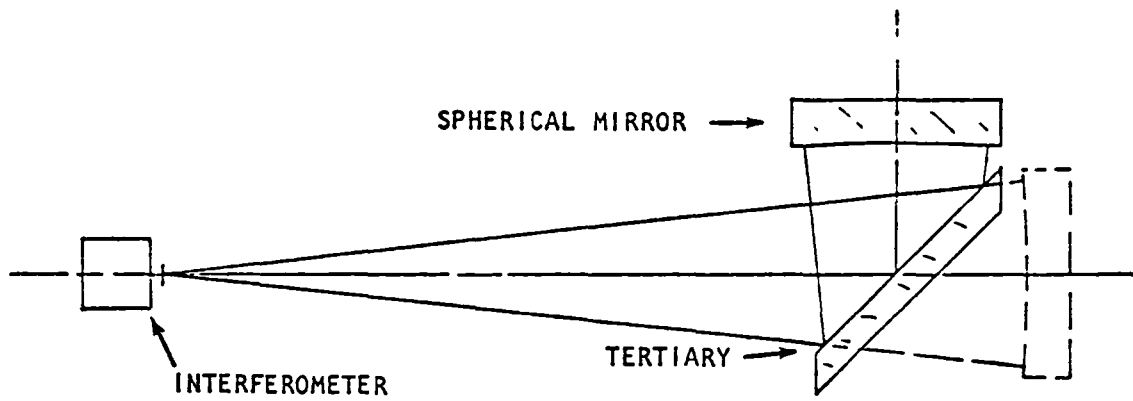
Fig. 15. Ritchey-Common Test of the Tertiary Mirror.

The final component of the system that was tested was the tertiary mirror. This plano mirror was tested in the classical fashion using the Ritchey-Common Test shown in Fig. 15. The advantage of using this test is that the mirror is tested at a 45° angle of incidence just as it is used in the telescope. Thus the wavefront produced by the mirror gives a one-to-one correlation with its effect on the telescope. The result of this test showed that the tertiary mirror had almost exactly one half wave of pure astigmatism. This amount of astigmatism in the tertiary mirror would be itself contribute a 0.33 arc second blur to the image. Figure 16 shows the radial energy distribution calculated for the tertiary mirror assuming the primary and secondary of the system are perfect.

We were surprised that the tertiary mirror had this large a figure error. It should be pointed out that these tests were run after the tertiary mirror had been coated. We ran a very cursory check on the tertiary mirror over a portion of the aperture prior to coating and the mirror looked at that time to be flat, certainly less than a quarter wave. Thus we were surprised to find after coating that the mirror did appear to have about a half wave of astigmatism. This led us to believe, as will be pointed out below, that there may be a certain problem
